# Characterizing the Middle Yegua, Davidson Creek and Deer Creek Watersheds Final Report

Prepared for the Texas State Soil and Water Conservation Board

**TSSWCB Project #18-52**

Appendix L: Middle Yegua, Davidson, and Deer Creek Characterization Report .....	54

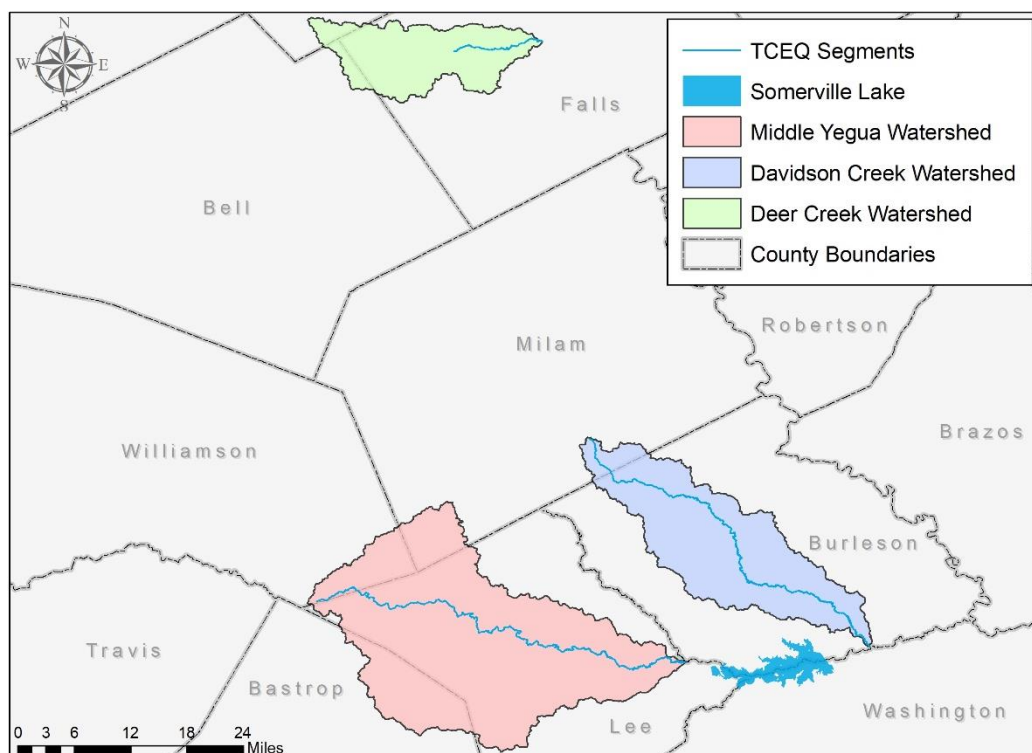
Figure 1. Overview of characterized watersheds

Middle Yegua Creek, Davidson Creek and Deer Creek are all located in the southern portion of the Brazos River Basin in separate watersheds (Figure 1). Middle Yegua Creek begins at the confluence with East Yegua and Yegua Creeks in Lee County and flows approximately 62 miles to the Lee County/Williamson County line. Middle Yegua Creek drains an area of approximately 440 square miles in Lee, Bastrop, Williamson and Milam counties. Davidson Creek is an intermittent stream with perennial pools that flows approximately 59 miles from the confluence of Yegua Creek to just over 1 mile above CR 322 in Milam County. Davidson Creek drains an area of approximately 218 square miles in Burleson and Milam counties. Deer Creek is a perennial stream that begins at the confluence of the Brazos River upstream and flows approximately 11 miles to the confluence of Dog Branch northwest of Lott. Deer Creek drains an area of approximately 115 square miles in Falls, McLennan and Bell counties. Each of the watersheds was evaluated separately throughout the project to reflect the individual characteristics and water quality issues of the waterbodies.

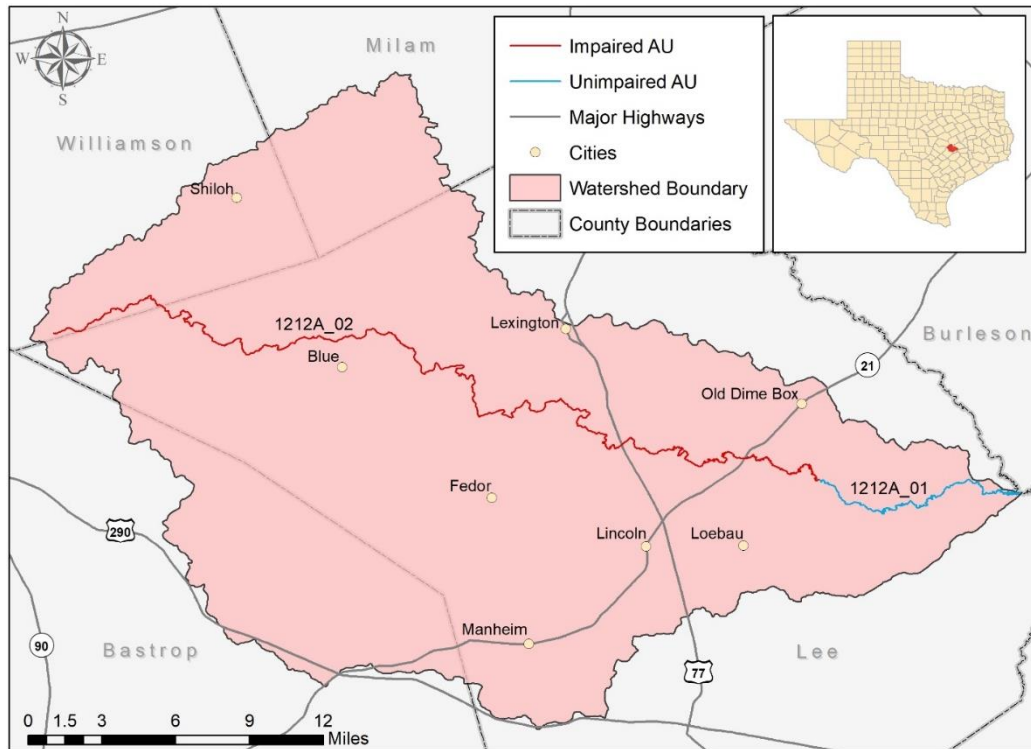
Figure 3. Middle Yegua Creek watershed

Middle Yegua Creek (Segment ID 1212A) begins at the confluence with East Yegua and Yegua Creeks in Lee County and flows approximately 62 miles to the Lee County/Williamson County line (**Error! Reference source not found.**). Middle Yegua Creek drains an area of approximately 440 square miles in Lee (73 percent), Bastrop (13 percent), Williamson (8 percent), and Milam (6 percent) counties. The segment is also divided into two assessment units (AU), 1212A\_01 and 1212A\_02.

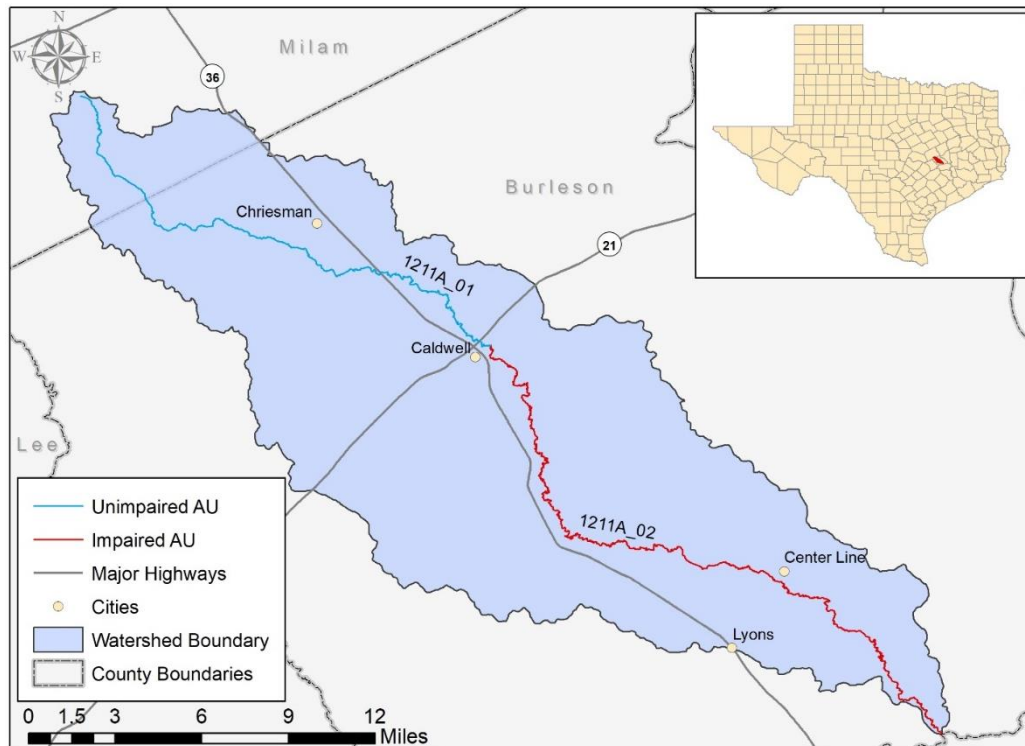
Figure 4. Davidson Creek watershed

Davidson Creek (Segment ID 1211A) is an intermittent stream with perennial pools that flows approximately 59 miles from the confluence of Yegua Creek to just over 1 mile above CR 322 in Milam County (**Error! Reference source not found.**). Davidson Creek drains an area of approximately 218 square miles in Burleson (93 percent) and Milam (7 percent) counties. The segment is also divided into two AUs, 1211A\_01 and 1211A\_02.

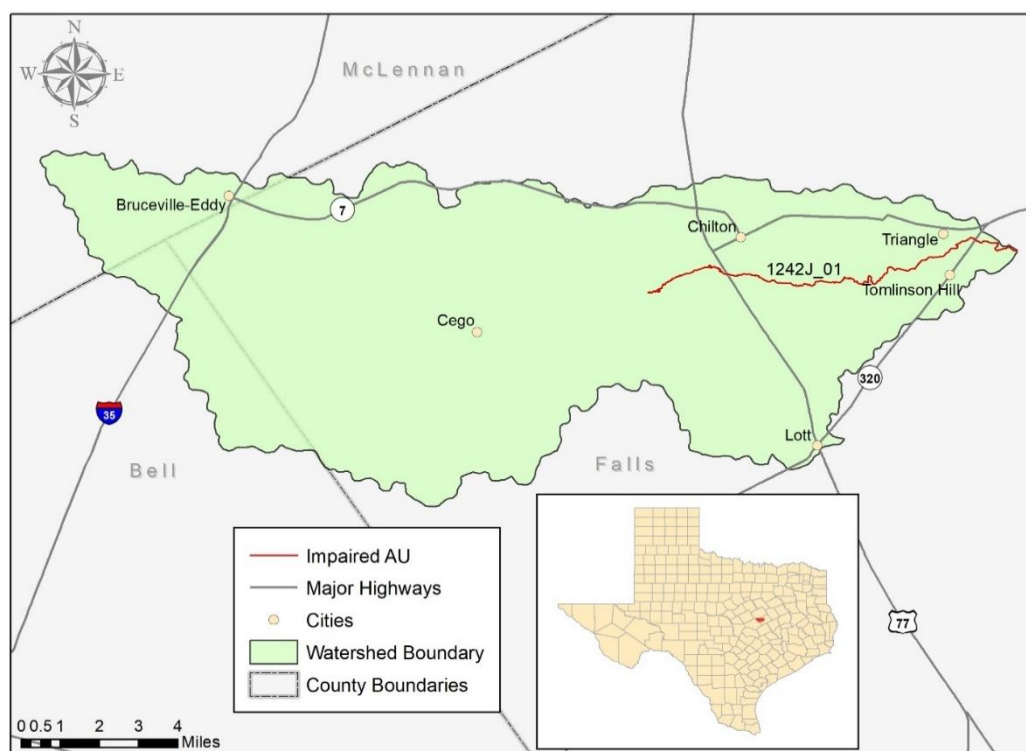
Figure 5. Deer Creek watershed

Deer Creek (Segment ID 1242J) is a perennial stream that begins at the confluence of the Brazos River upstream and flows approximately 11 miles to the confluence of Dog Branch northwest of Lott (**Error! Reference source not found.**). Deer Creek drains an area of approximately 115 square miles in Falls (87 percent), McLennan (7 percent), and Bell (6 percent) counties. The segment consists of a single AU, 1242J\_01.

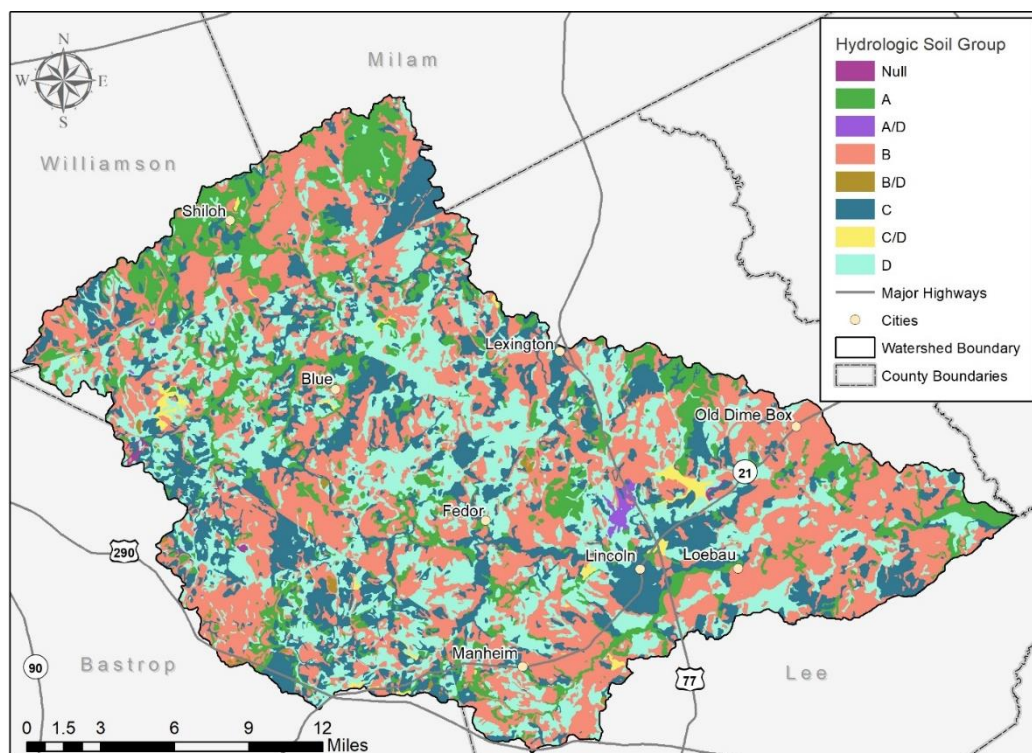
Figure 9. Middle Yegua Creek watershed Hydrologic Soil Groups

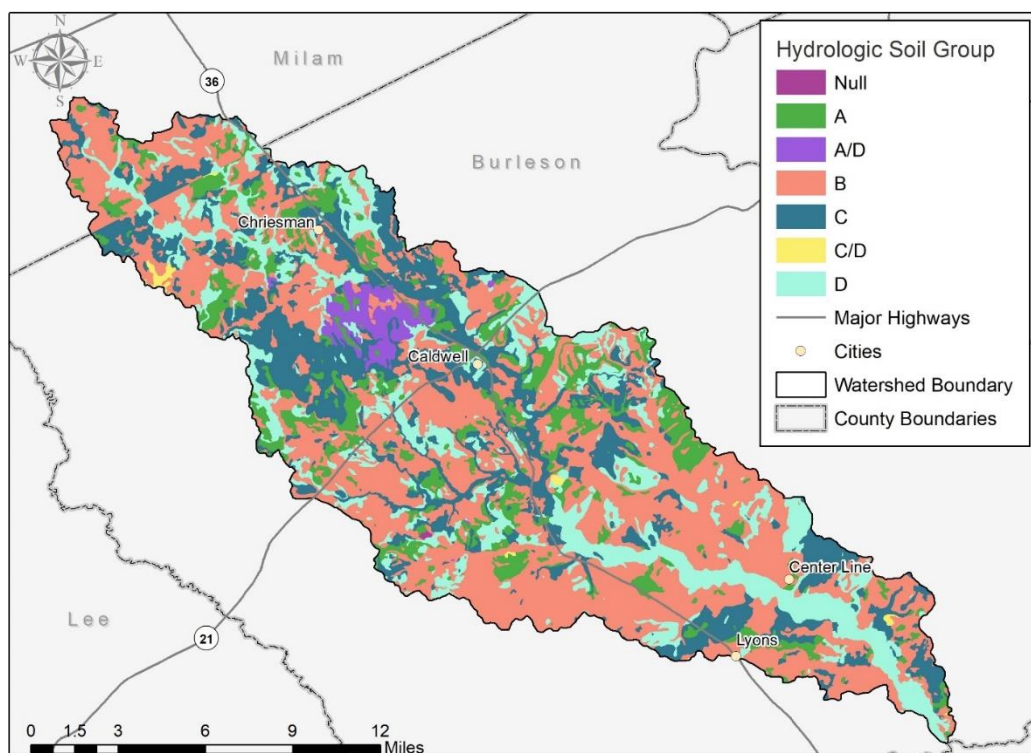
Figure 10. Davidson Creek watershed Hydrologic Soil Groups

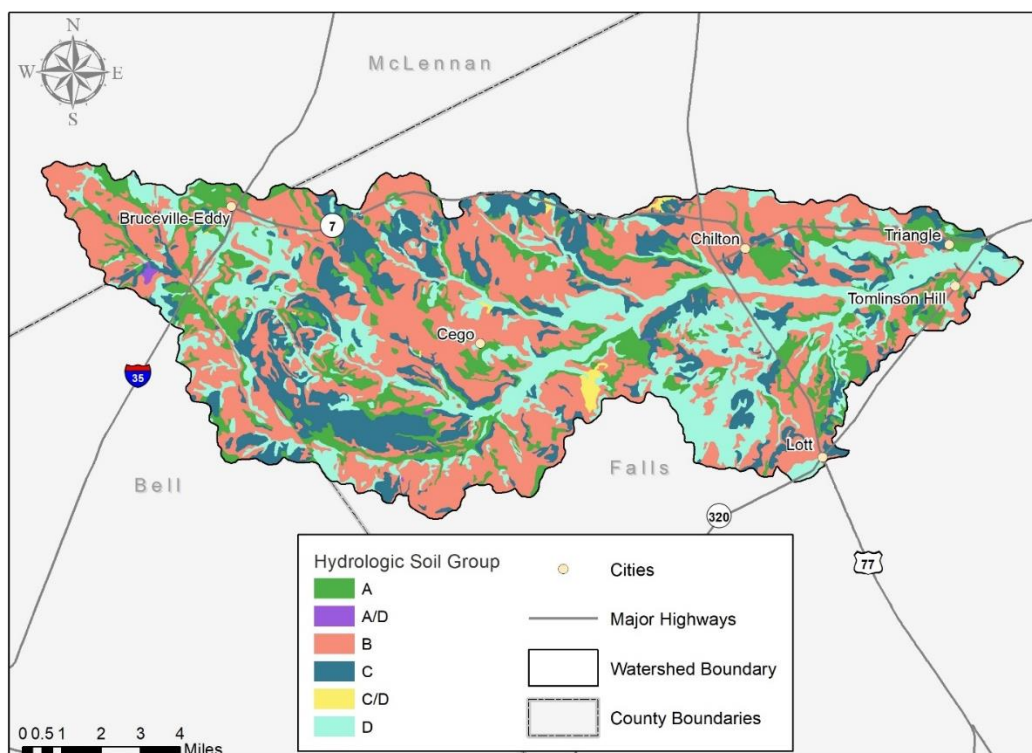
Figure 11. Deer Creek watershed Hydrologic Soil Groups

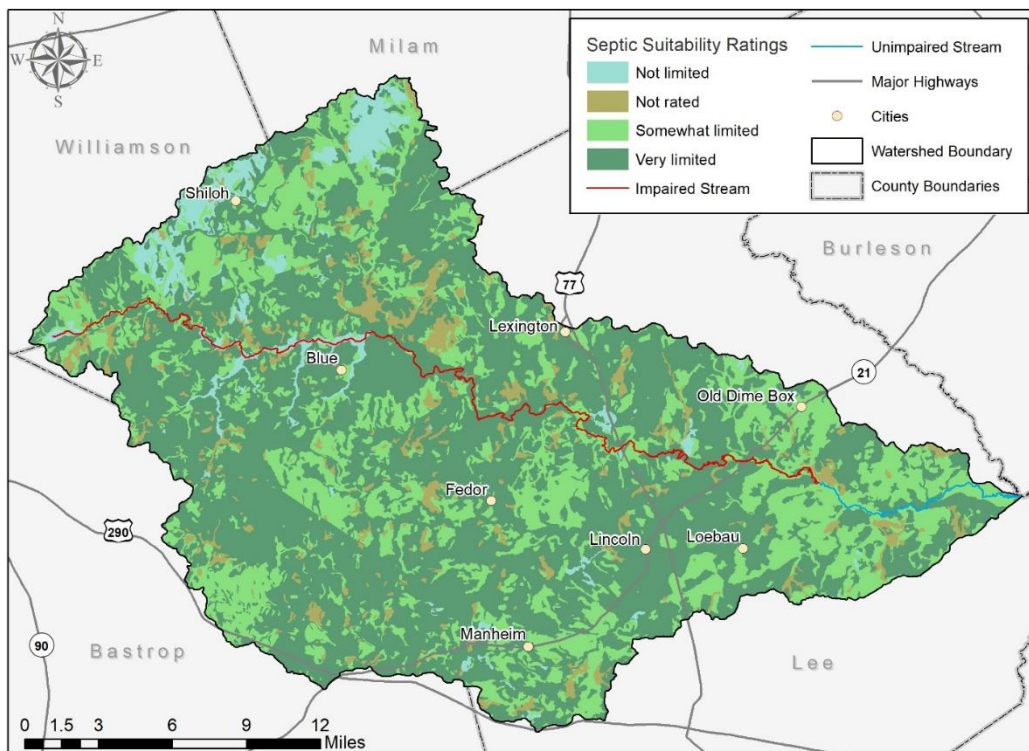
Figure 12. Middle Yegua Creek watershed OSSF adsorption field ratings

The USDA NRCS provides suitability ratings for septic tank absorption fields based on soil properties, depth to bedrock or groundwater, hydraulic conductivity, and other properties that may affect the absorption of on-site sewage facilities (OSSF) effluent, installation, and maintenance. A “Not Limited” rating indicates soils with features favorable to OSSF use. “Somewhat Limited” indicates soils that are moderately favorable, with limitations that can be overcome by design, planning, and installation. “Very Limited” indicates soils that are very unfavorable for OSSF use, with expectation of poor performance and high amounts of maintenance. The majority of the soils in all three watersheds are rated “Very Limited” for OSSF use, followed by smaller areas rated “Somewhat Limited” (**Error! Reference source not found., Error! Reference source not found., Error! Reference source not found.**) (NRCS, 2019).

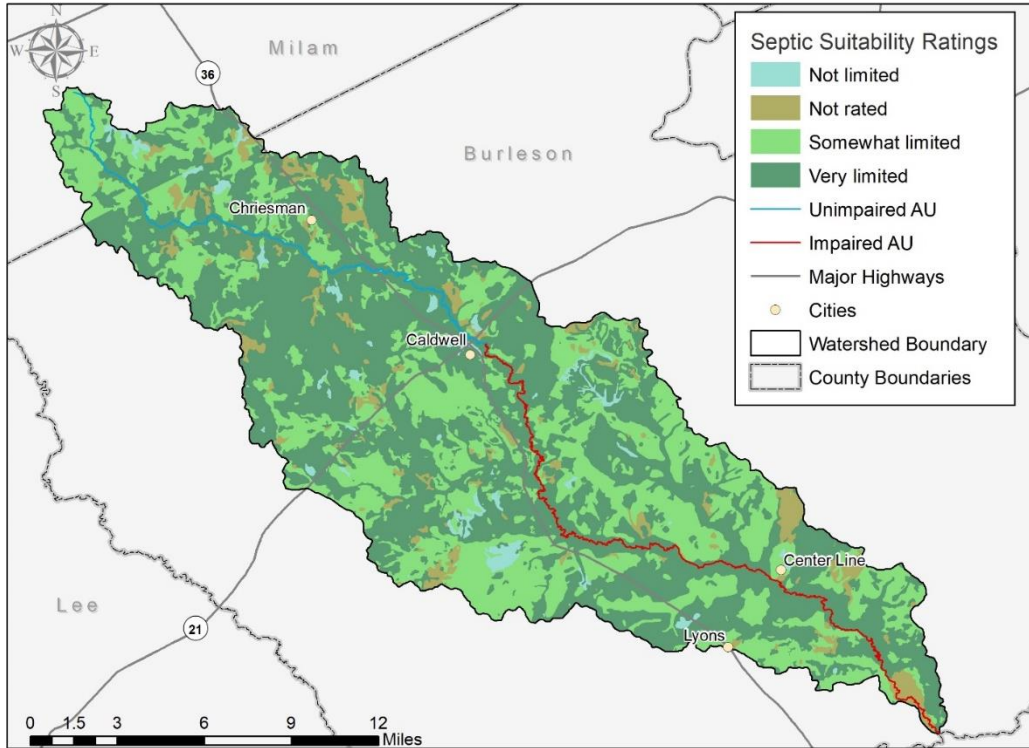
Figure 13. Davidson Creek watershed OSSF adsorption field ratings

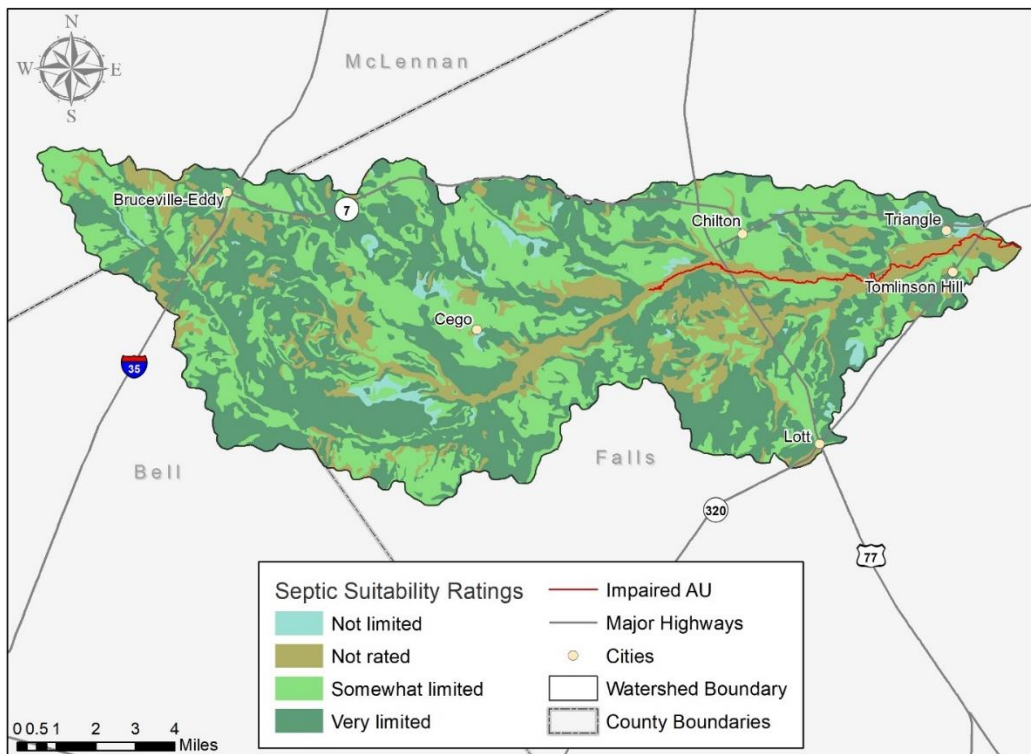
Figure 14. Deer Creek watershed OSSF adsorption field ratings

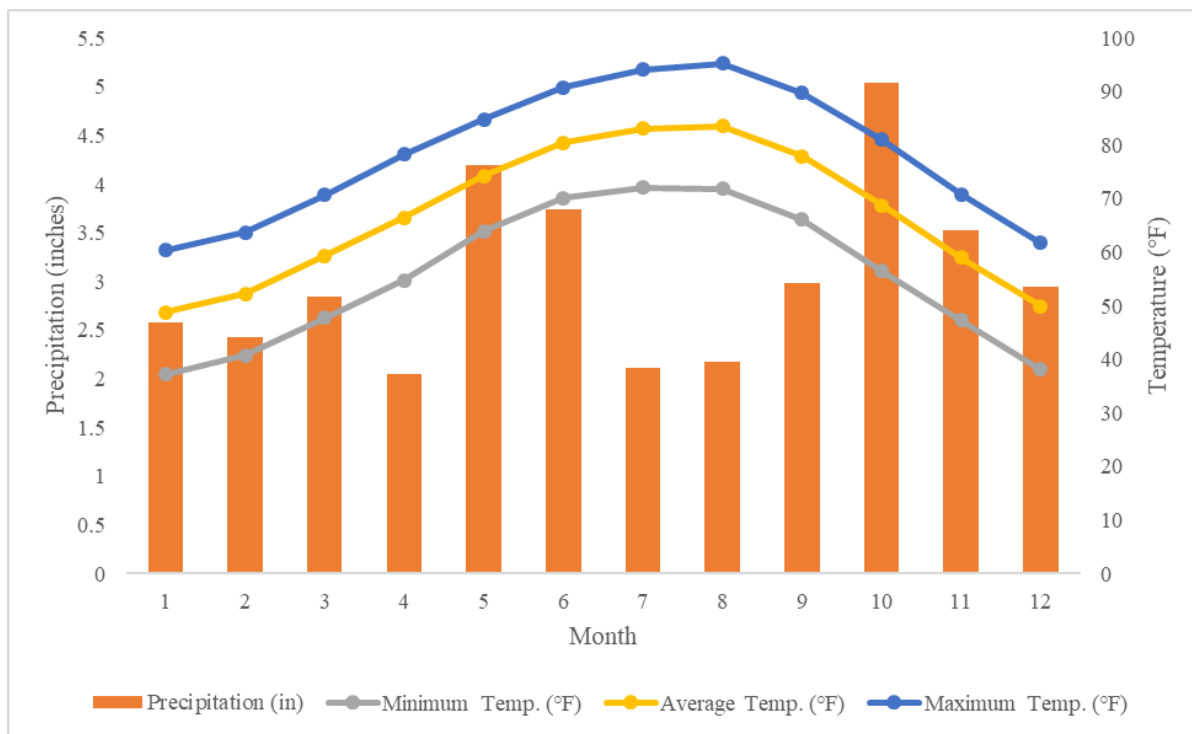
Figure 21. Monthly climate data, including precipitation, normal average, maximum and minimum air temperature, for Lexington, Texas from 1981-2010 (NOAA, 2016).

There is one active weather station recording precipitation and temperature data in the Middle Yegua Creek watershed. That weather station is the Lexington, TX USC00415193 weather station (NOAA, 2016) and it was used to determine the approximate precipitation and temperature data for the watershed (**Error! Reference source not found.**). Monthly normal air temperature indicates daily mean air temperature was 66.9°F (NOAA, 2016). Minimum average daily temperatures reached a low of 37.2°F in January. The maximum average daily temperature reached a peak of 95.3°F in August. Monthly normal precipitation, from the weather station, indicates that the area had a mean annual rainfall from 1981-2010 of 36.6 inches (NOAA, 2016). Rainfall normally peaks in October (5.04 inches) with the lowest totals occurring in April (2.05 inches) (NOAA, 2016). Average annual precipitation values across the study area from the PRISM Climate Group at Oregon State (2012) indicate average annual rainfall ranges from 34 to 38 inches per year across the watershed, with a clear East to West decreasing gradient (**Error! Reference source not found.**).

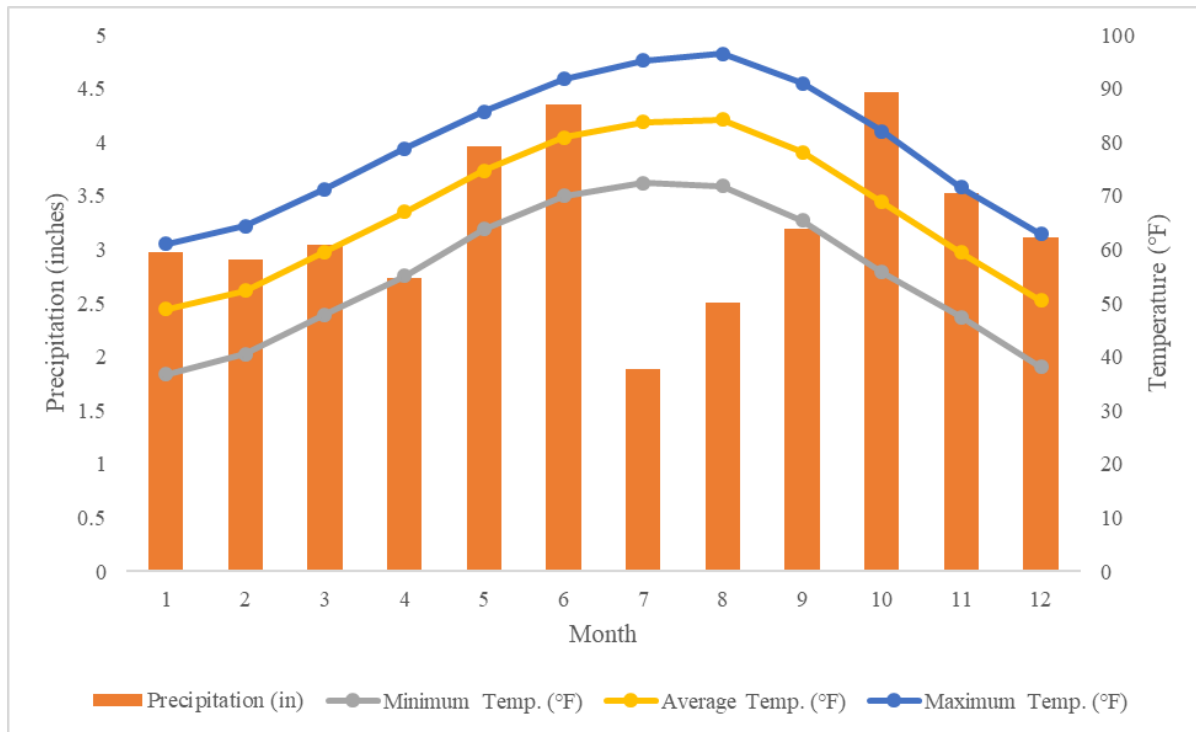
Figure 23. Monthly climate data, including precipitation, normal average, maximum and minimum air temperature, for Somerville Dam, Texas from 1981-2010 (NOAA, 2016).

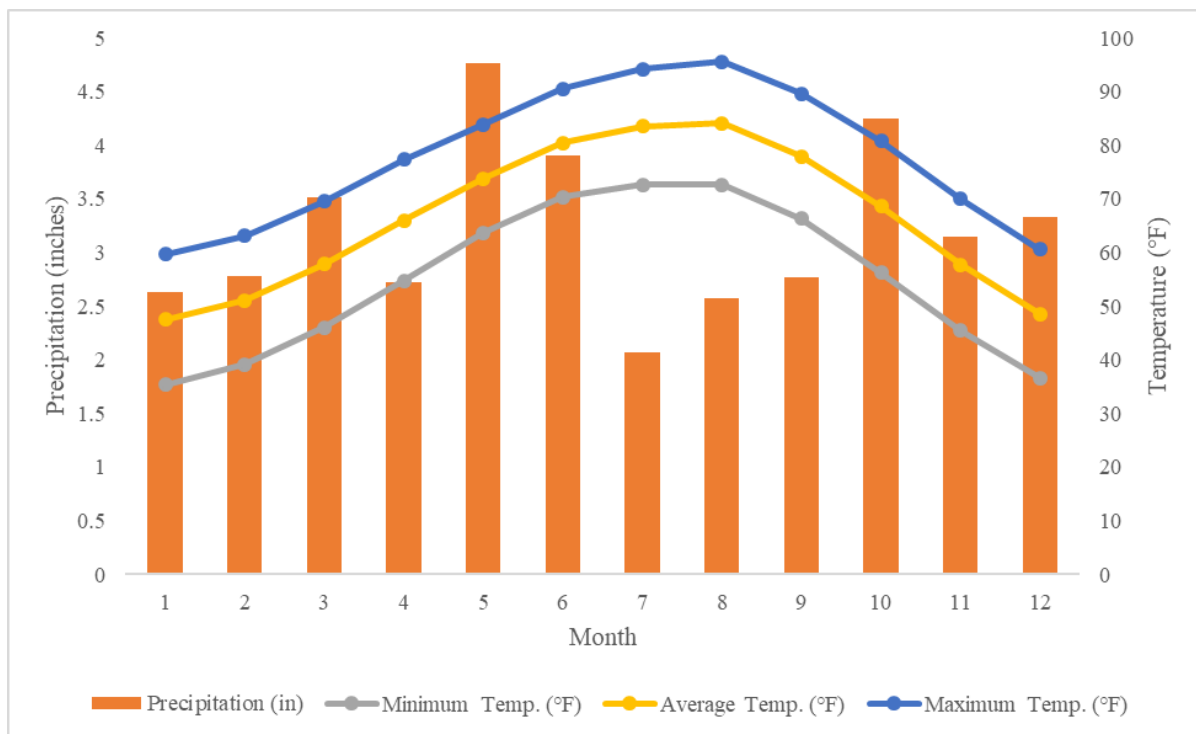
Figure 25. Monthly climate data, including precipitation, normal average, maximum and minimum air temperature, for Marlin, Texas from 1981-2010 (NOAA, 2016).

The weather station chosen to determine the approximate precipitation and temperature data for the Deer Creek watershed was the Marlin, TX USC00415611 station (NOAA, 2016) (**Error! Reference source not found.**). Monthly normal air temperature indicates daily mean air temperature was 66.4°F (NOAA, 2016). Minimum average daily temperatures reached a low of 35.4°F in January. The maximum average daily temperature reached a peak of 95.6°F in August. Monthly normal precipitation, from the weather station, indicates that the area had a mean annual rainfall from 1981-2010 of 38.5 inches (NOAA, 2016). Rainfall normally peaks in May (4.76 inches) with the lowest totals occurring in July (2.07 inches) (NOAA, 2016). Average annual precipitation values across the study area from the PRISM Climate Group at Oregon State (2012) indicate average annual rainfall ranges from 35 to 36 inches per year across the watershed (**Error! Reference source not found.**).

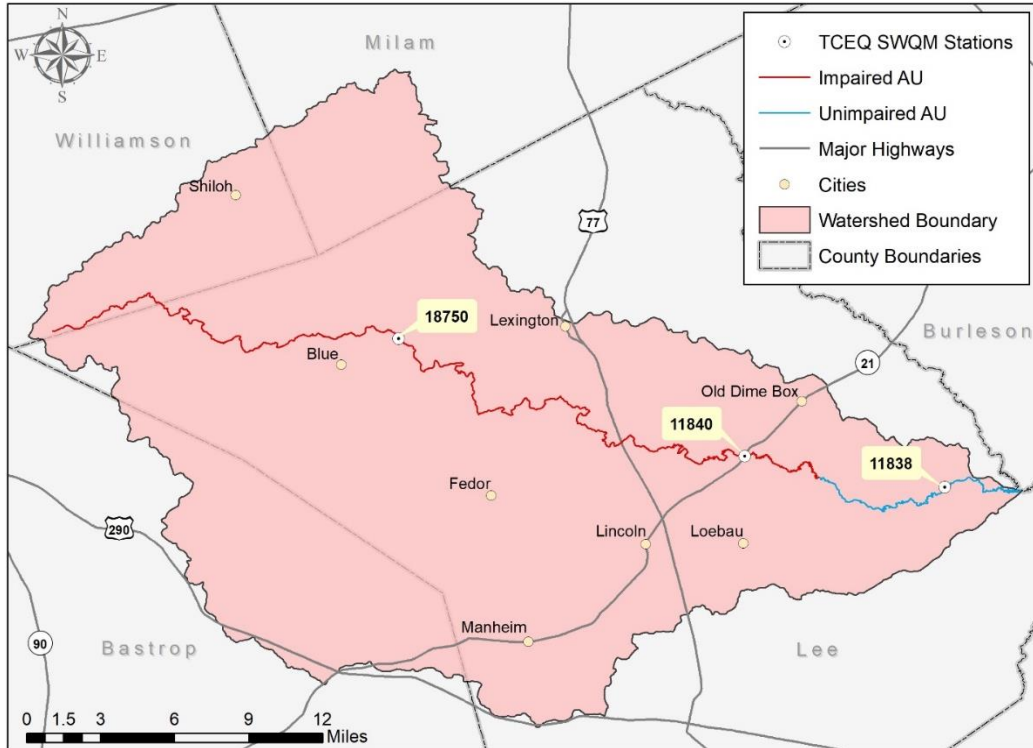
Figure 33. SWQM stations in the Middle Yegua Creek watershed

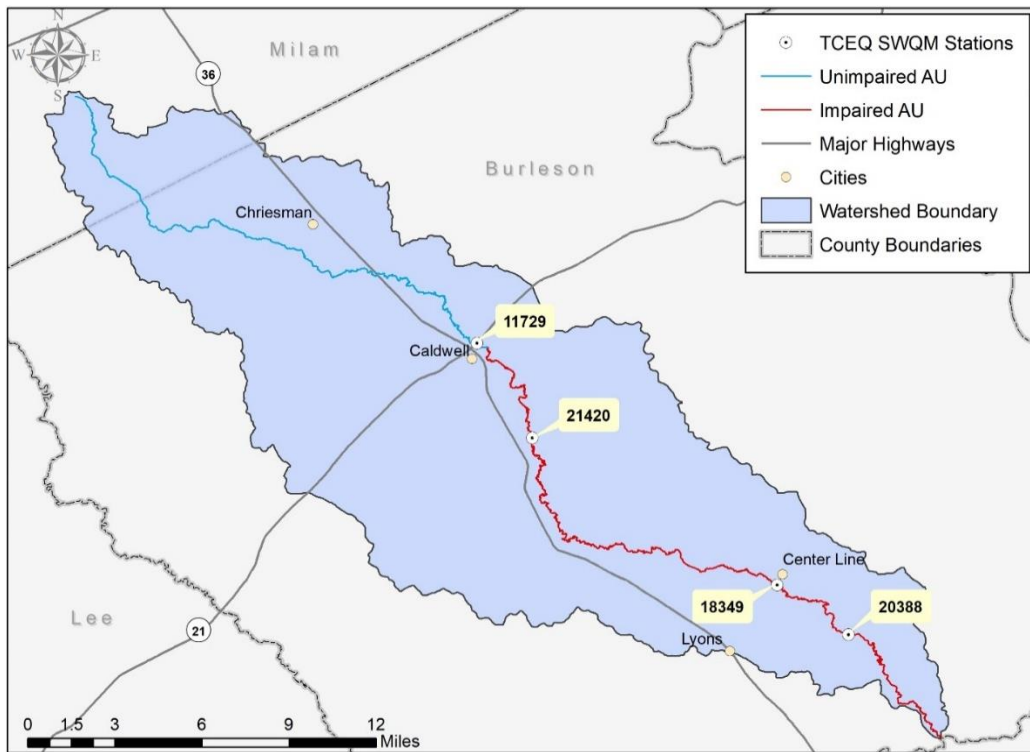
Figure 34. SWQM stations in the Davidson Creek watershed

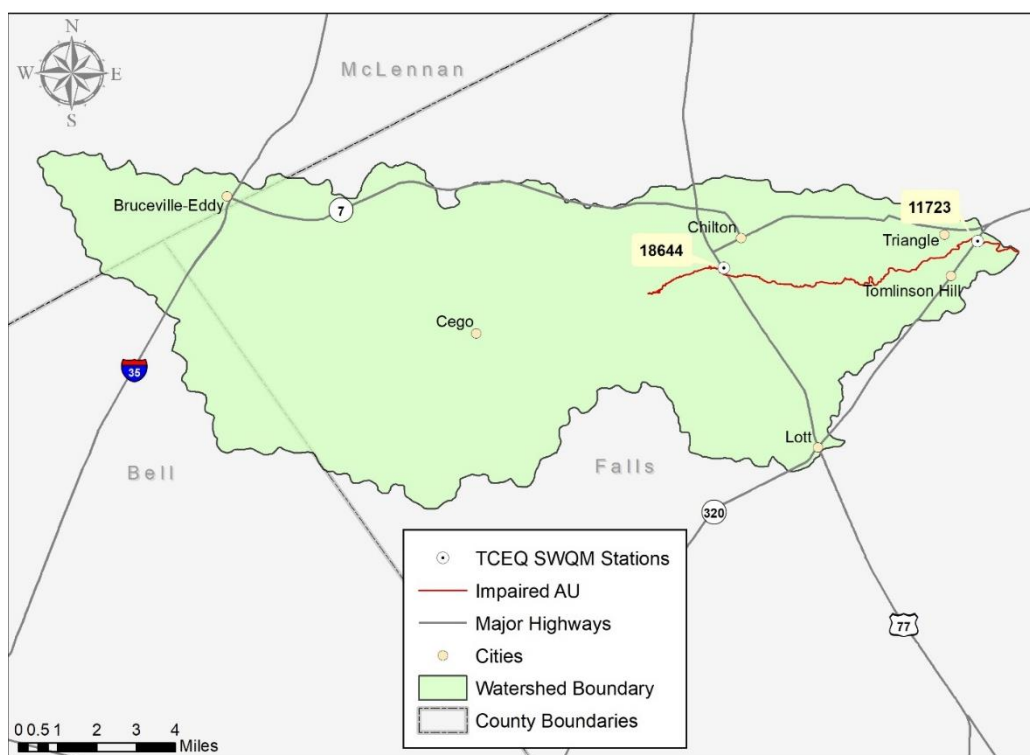
Figure 35. SWQM stations in the Deer Creek watershed

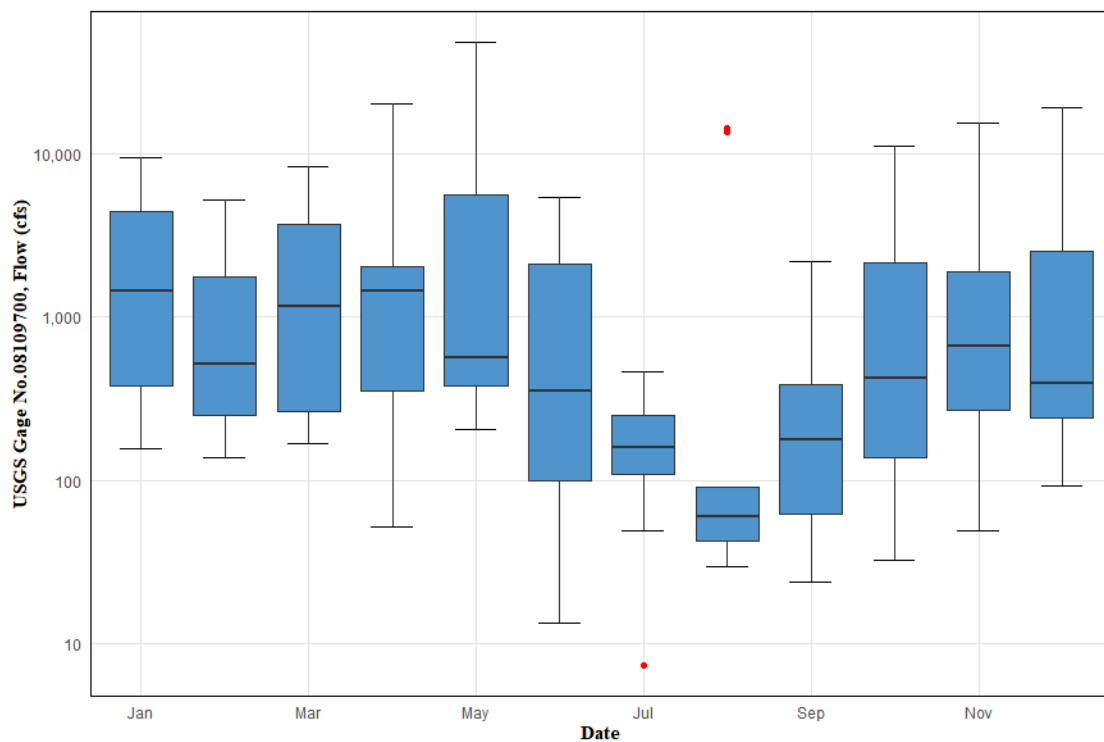
Figure 45. Aggregated monthly streamflow for Middle Yegua Creek from January 2009 through December 2019

There are two United States Geological Survey (USGS) streamflow gages in the watersheds. USGS streamflow gage 08109700 is located at SWQM Station 11840 in Middle Yegua Creek. Instantaneous streamflow information is available at this station dating back to August 1962. A second streamflow gage (08110100) is located at SWQM Station 18349 in the lower portion of the Davidson Creek watershed. This gage has instantaneous streamflow records dating back to October 1962. Instantaneous streamflow data for each gage was used to calculate the monthly aggregated streamflow from January 2009 through December 2019 (**Error! Reference source not found., Error! Reference source not found.**).

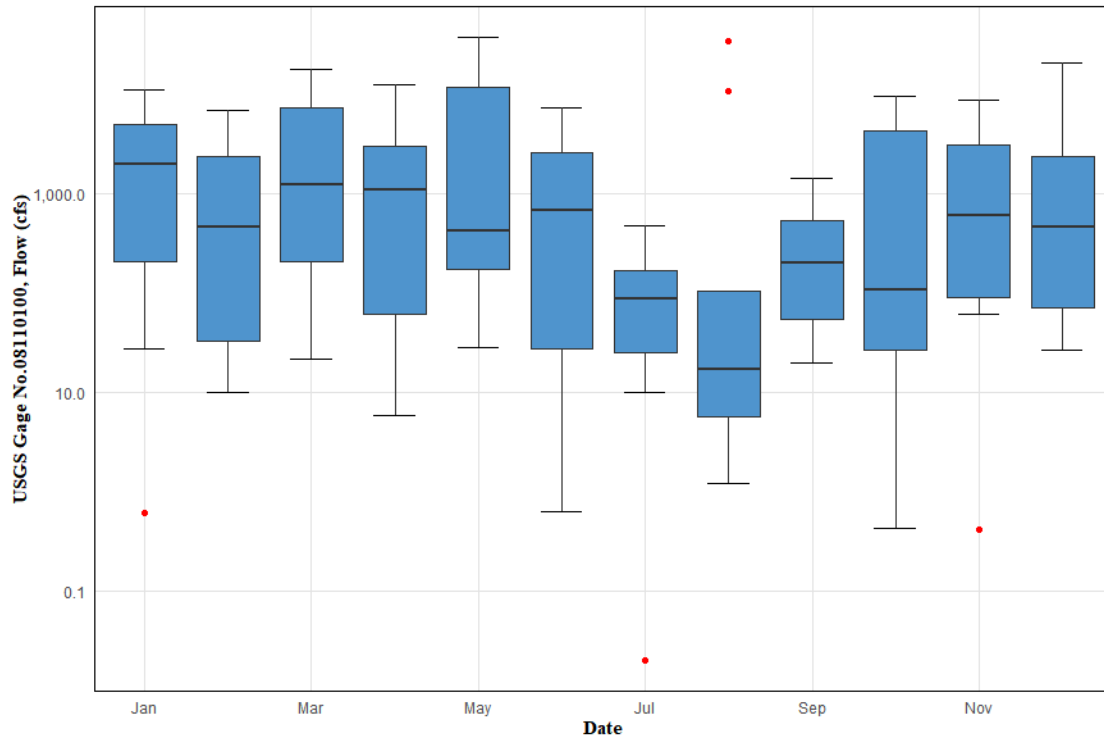
Figure 46. Aggregated monthly streamflow for Davidson Creek from January 2009 through December 2019

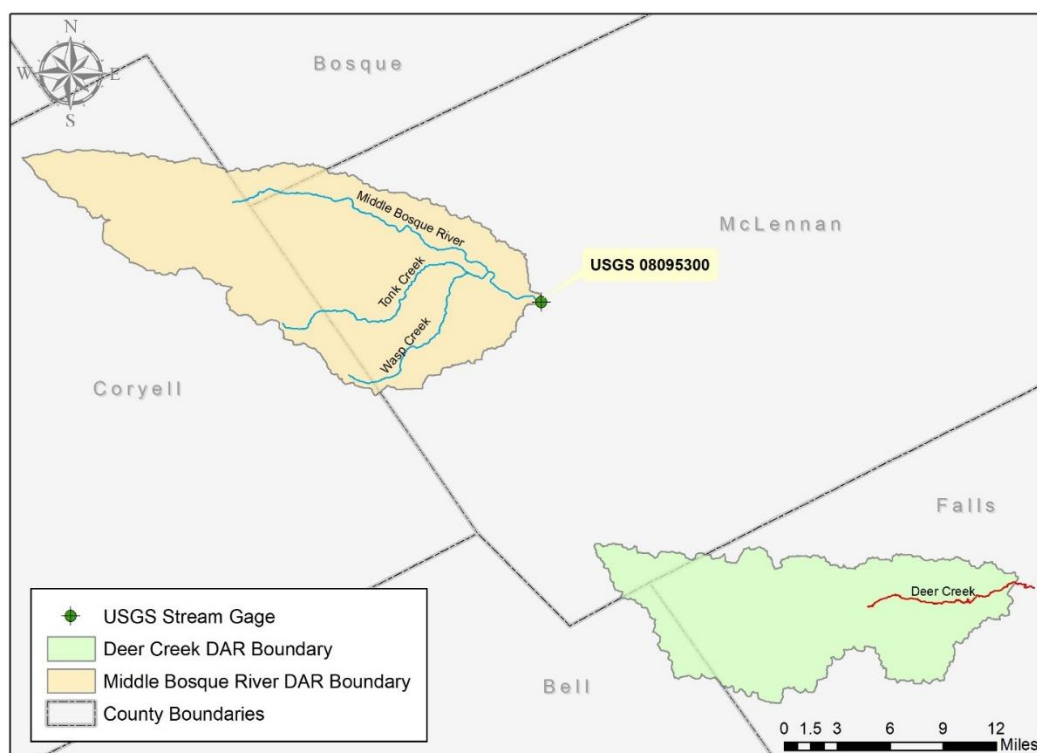
Figure 47. USGS streamflow gage and watershed used in streamflow development for Deer Creek

For the Deer Creek DAR, USGS gauge 08095300 on the Middle Bosque River was chosen. The Middle Bosque River watershed was ideal, as it is near the Deer Creek watershed, and is comparable in size, land use and land cover. The dataset for the Middle Bosque River included ten years' worth of daily streamflow records, dating back to January 2009. Most of the elevated loadings occurred during higher flow conditions while lower flow conditions loadings were typically below the exceedance line. This is indicative of loadings associated with NPS pollution or from bacteria present within stream sediments that are resuspended under increased flow.

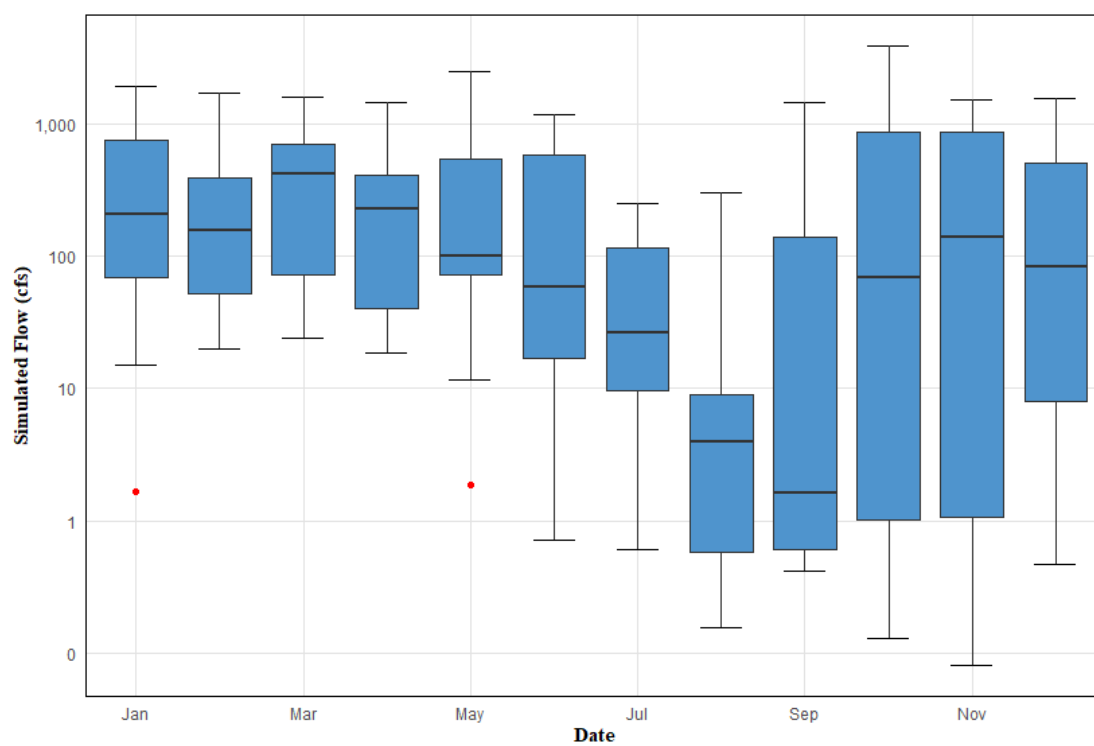
Figure 48. Aggregated monthly streamflow for Deer Creek from January 2009 through December 2019

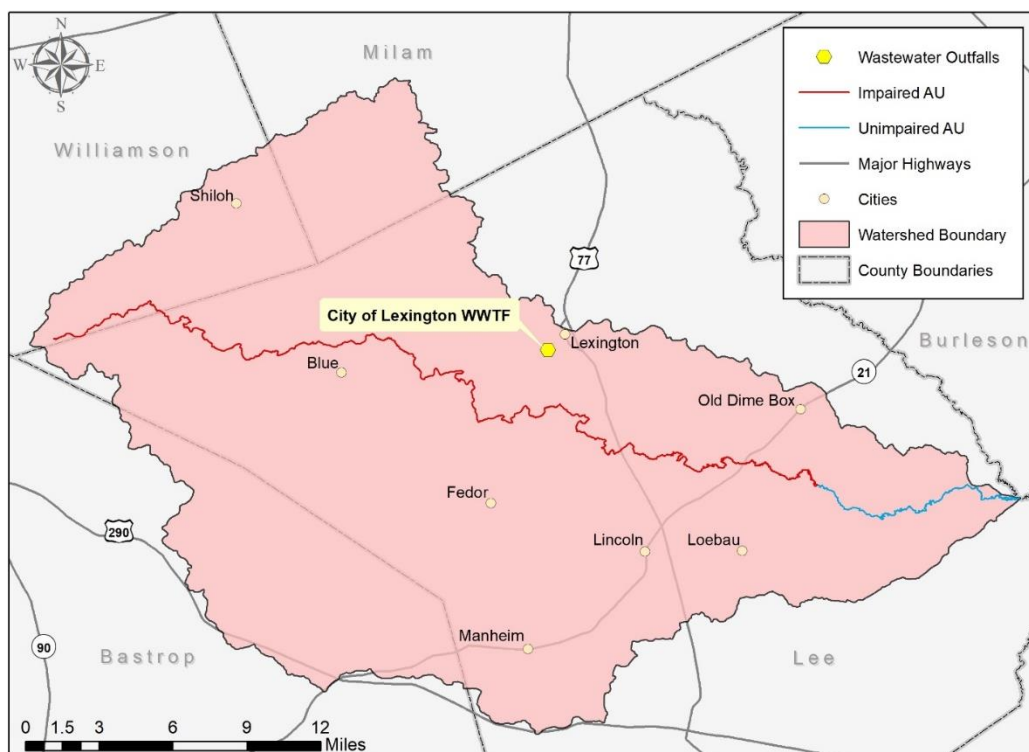
Figure 52. Active permitted wastewater discharge outfall locations for the Middle Yegua Creek watershed

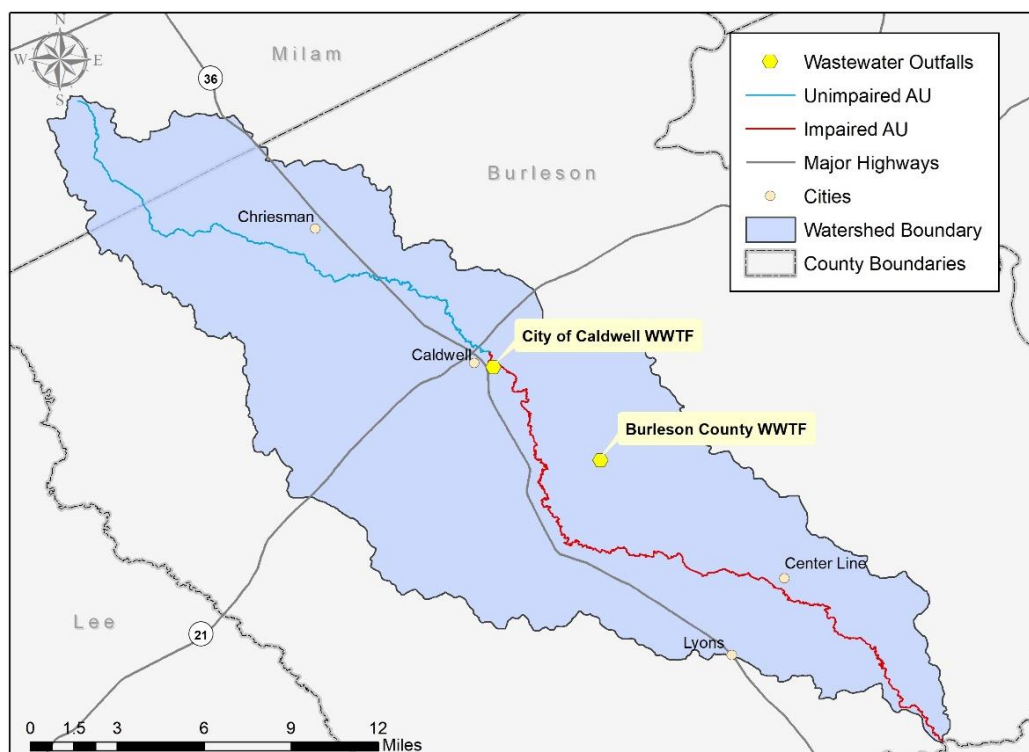
Figure 53. Active permitted wastewater discharge outfall locations for the Davidson Creek watershed

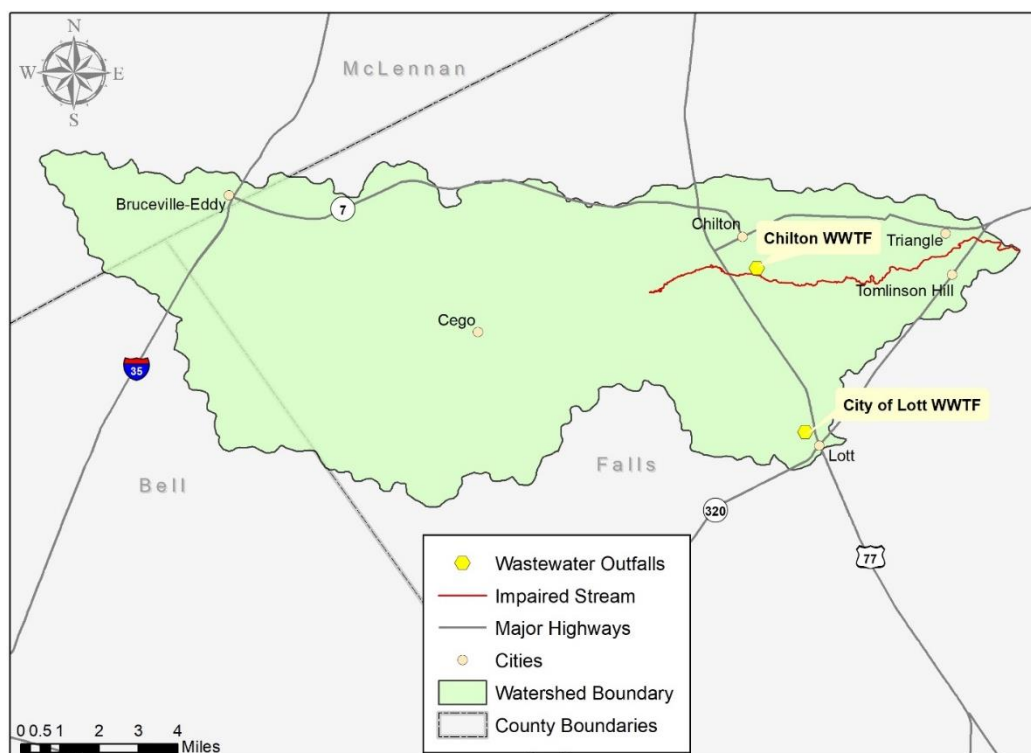
Figure 54. Active permitted wastewater discharge outfall locations for the Deer Creek watershed

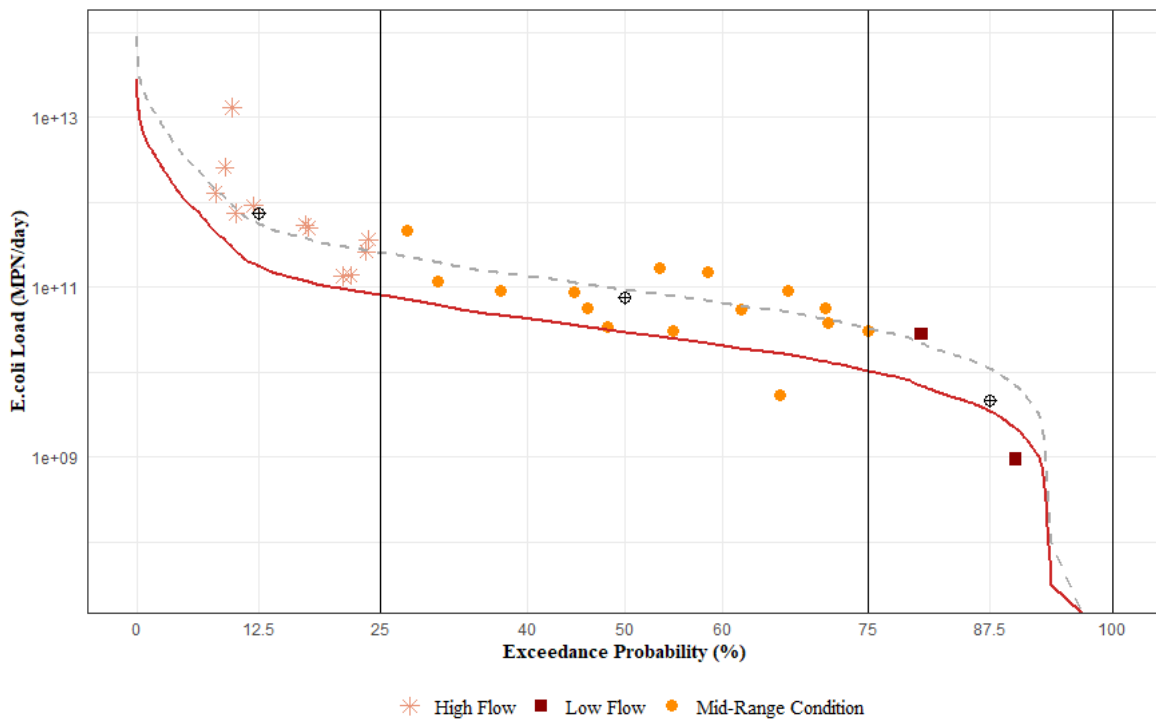
Figure 55. Load duration curve for Middle Yegua Creek SWQM stations 18750 and 11840. The solid red line indicates the allowable load at geomean criterion (126 MPN/100mL) and the gray dashed line is allowable load at single sample criterion (399 MPN/100mL). The black circles indicate the existing geomean load in each flow regime (MPN/day)

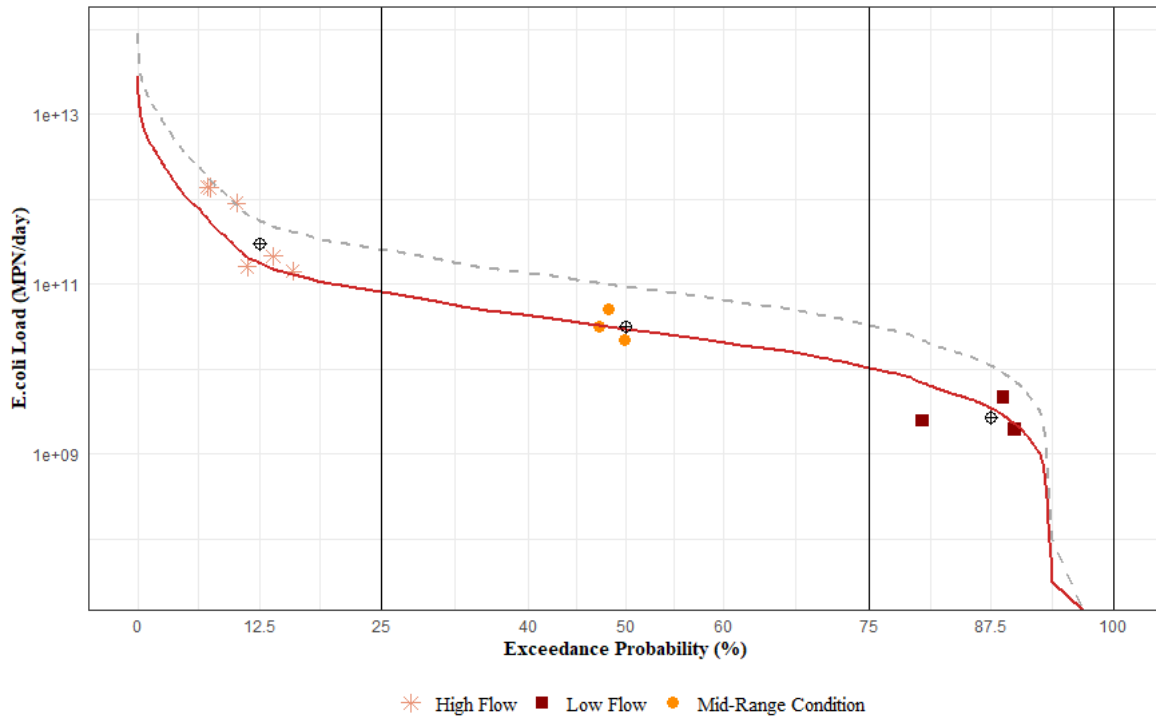
Figure 56. Load duration curve for Middle Yegua Creek SWQM station 11838. The solid red line indicates the allowable load at geomean criterion (126 MPN/100mL) and the gray dashed line is allowable load at single sample criterion (399 MPN/100mL). The black circles indicate the existing geomean load in each flow regime (MPN/day)
